Exploring Translocation of *Omah* Java in Pawon Garden, Bogor

A Case Study of Ex-situ Architectural Conservation

Abstract – Pawon Garden is a building complex located in Parung, Bogor, consisting of several translocated Javanese vernacular (*Omah*) buildings. This study aims to determine the process of translocation of Javanese *Omah* in Pawon Garden Parung in a narrative manner, resulting in knowledge about the translocation of Javanese vernacular buildings as an effort of ex-situ conservation in architectural terms. This study uses a qualitative descriptive approach to show the translocation process of Javanese vernacular buildings, starting from technical specifications, elements, and materials. The building translocation process discussed in this study is divided into three stages: the dismantling process, the translocation process, and the reconstruction process. Several changes to the building occur as a form of adjustment of the building to its new environment and functions. The changes reduce the authenticity of the building. However, most of the elements and structures in the translocated Javanese *Omah* are still the original components of the original building.

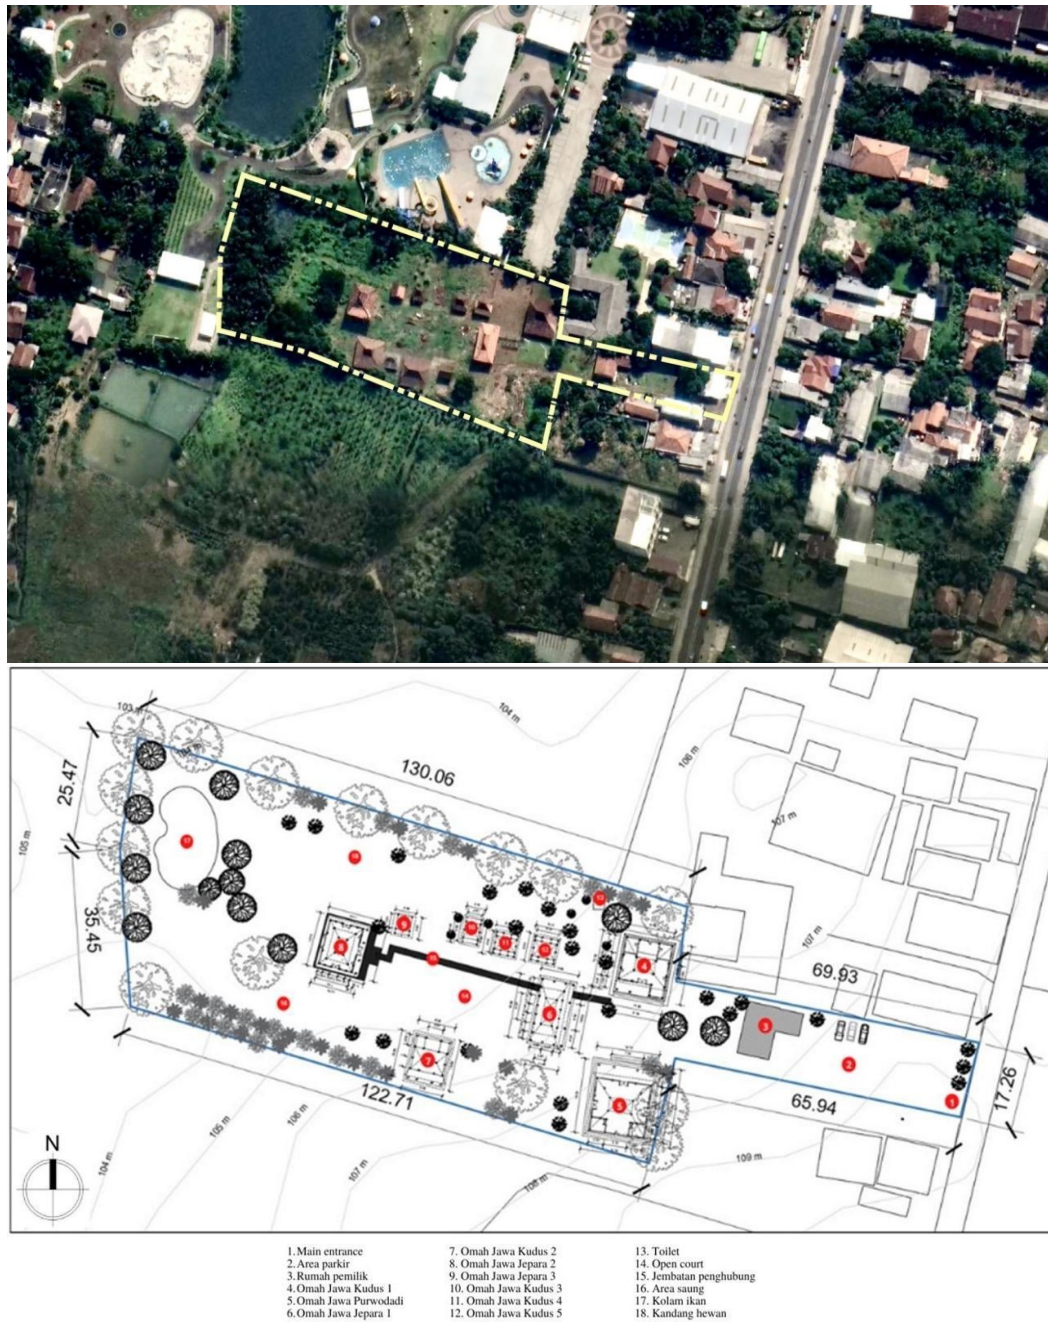
Fig. 1. Pawon Garden's Location in Parung, Bogor Regency (Top); Pawon Garden's Map (Below)
Source: *Google Earth* and author's redraw (2022)

This research is located at Pawon Garden on Jalan Raya Parung, RT.02/RW.01, Pemagarsari Village, Parung District, Bogor, West Java (see Fig. 1). In this study, Pawon Garden was used as the research location by taking nine translocated Javanese vernacular buildings as the focus. This research used a qualitative study approach. The data were taken qualitatively by interviews and direct observation of the phenomena in the field. By observation, capturing existing phenomena, and interviewing sources, this research was structured descriptively using direct experience during observation, assisted by field notes, some photographic documentation, and several interviews to get a holistic picture (Creswell, 2014). This research also uses a case study approach. Case study research is a qualitative method that can stand alone (Denzin & Lincoln, 2009). It is helpful for gaining an in-depth appreciation of an interesting problem, event or phenomenon in a natural, real-life context (Crowe, et al., 2011). The results of the data from the qualitative research were then analyzed and explained descriptively to explain the process of translocation of Javanese *Omah* at Pawon Garden in Parung Bogor.

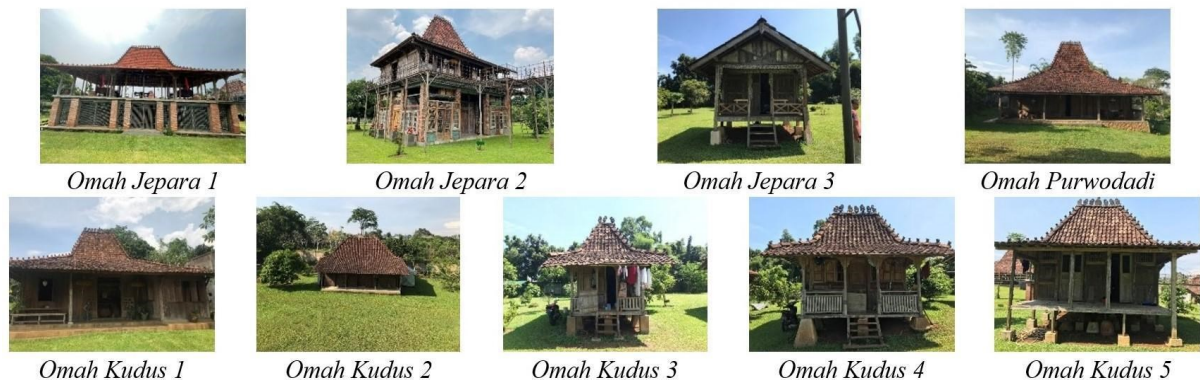
Fig. 2. Translocated Javanese *Omah* in Parung Garden
Source: Authors (2022)

In addition to the nine Javanese *Omahs* (see Fig. 2), there are several other additional buildings, such as the addition of two separate modern bathrooms made of brick at both ends of the site. Over time, the owner added three small *saung* on the west side of the site. This *saung* is made of bamboo and wood. There is also a cage for livestock and a dog cage. In 2022, staff dormitories will also be built to house the staff who previously lived in one of the translocated *Omah Kudus*. The staff dormitories are modern buildings made of bricks but still use Javanese building accents such as Javanese carvings and stained glass with floral motifs.

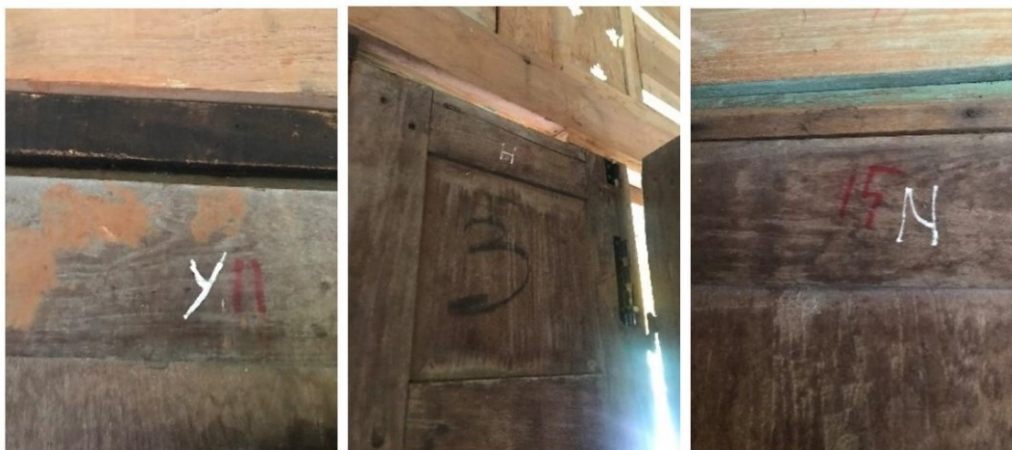
Fig. 3. Examples of How the Handyman Coded the Reconstructed Panel
Source: Authors (2022)

After the building is dismantled, some building components, such as pillars and panels, are marked or coded (see Fig. 3). According to the owner, the builders will use all means so that the building components are not mixed and swapped. The various ways of marking are done by using letters, numbers, and combinations of letters and numbers such as A-1, B-2, and C-3. Some components are color coded. The marking is done using paint, markers, and scraping the components with sharp objects. The owner stated that when the building component was installed, it would look bad because of the code. When using paint, the marking can still be removed. However, markings made by scraping will be difficult to remove. Other building components, such as roof tiles and roof trusses, are not coded or marked because they are similar and can be used in an adapted way without changing the shape and essence of the building.

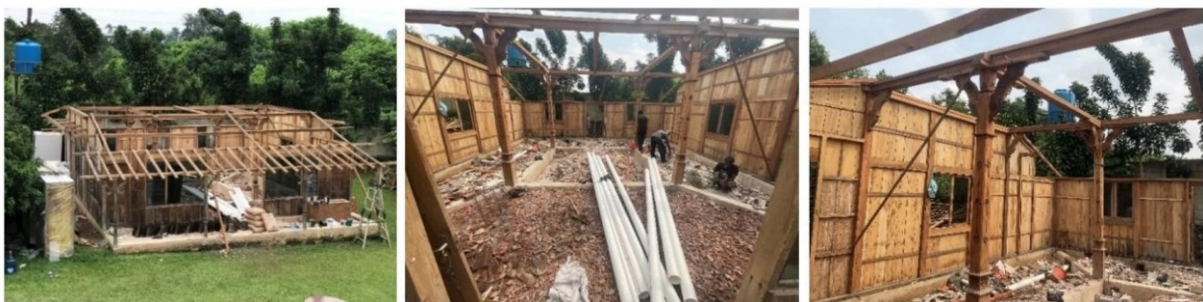
Fig. 4. The Third Reconstruction Process of *Omah* Kudus 2 in 2022
Source: Authors (2022)

The reconstruction process began in 2014 and lasted for about a year. However, in 2017, two Javanese *Omahs* were reconstructed, namely *Omah* Purwodadi and *Omah* Kudus 3. The Javanese

Omahs were dismantled, reassembled, and retrofitted due to poor initial construction and slanted installation. The owner, assisted by the head of the craftsman (foreman), plans how the *Omah* building can stand firm—starting from planning the foundation, strengthening the building so that it does not move due to unstable soil, and preserving and preventing termites. The wood components that have been translocated are also treated with termite repellent. Periodically, the building will be given another termite repellent every three months.

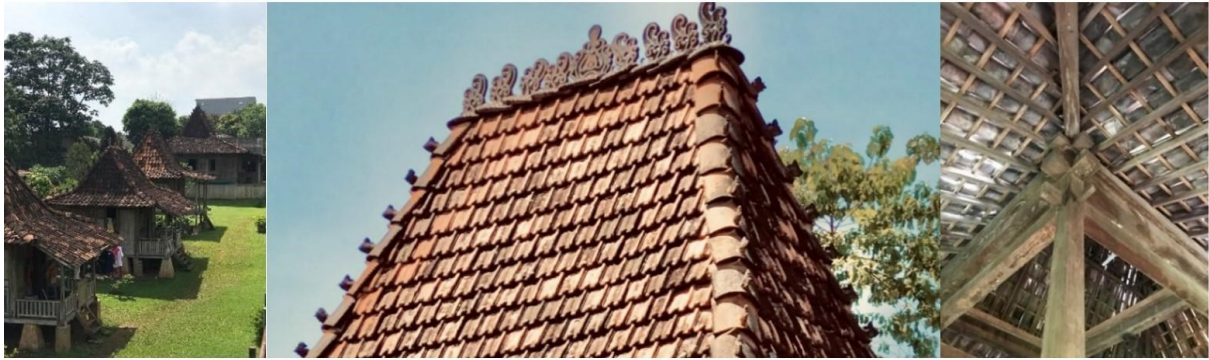
Fig. 5. Several Preserved Elements of *Omah*
Source: Authors (2022)

The translocation process of the building carried out by the owner has made the translocated Javanese *Omah* experience several changes. These changes occur as a form of adjustment of the building to its new environment and functions. In general, the changes between one building and another have similarities. The building elements that have undergone the most changes are the foundation and floor elements (see Fig. 6). All buildings have their foundations renewed to match the contours of the land in their new location and strengthen the building.

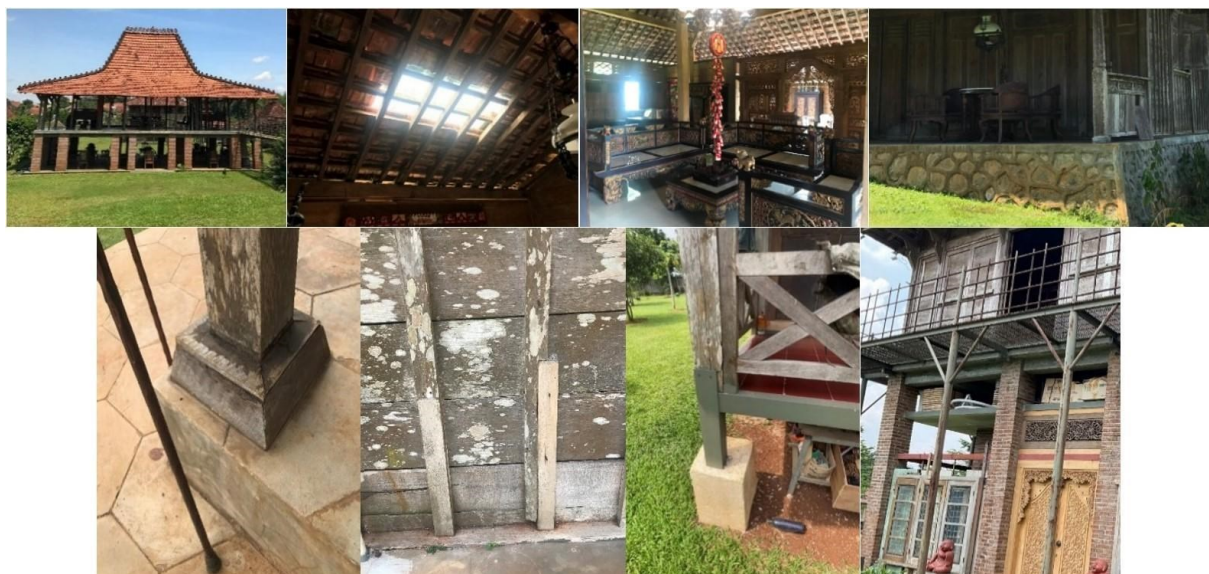
Fig. 6. Several Adjustments to Beautify *Omah*'s Appearance
Source: Authors (2022)

The addition of ceramic floors in each building is carried out to increase its residents' comfort and beautify the building's appearance. However, it is considered a way to reduce the authenticity of the building. The building that experienced the most significant changes was *Omah* Jepara 1. The building that had the most negligible changes was *Omah* Jepara 3. *Omah* Kudus 3, 4, and 5 had a few changes that tended to be similar: the complete replacement of wooden floor slabs and pedestal foundations (*umpak*) made of wood and stone into steel floor plates and a framework made of steel and cast concrete. The part of all the pristine buildings is the pillar of the *saka guru*. The entire building still has the *saka guru* intact and has not given any reinforcement.

Aesthetic factors change the translocated buildings due to the need to beautify the visual appearance of the building. These changes are in the form of building elevations as well as adding or reducing building elements. The changes can be seen in the use of ornaments, finishing of concrete column heights, using materials that are following the original building, adding *gebyok*, and much more. This aesthetic adjustment gives the building a significantly more refreshed look. Although it has undergone several changes, the materials and elements used are still similar and are sought to be in harmony with the original building.
