The Challenges in Conserving the Heritage Based on Conservation Practice of AA Maramis Building in Jakarta

Bambang Eryudhawan¹, Andi²⁾

¹Cultural Heritage Board of Jakarta, Jakarta, Indonesia

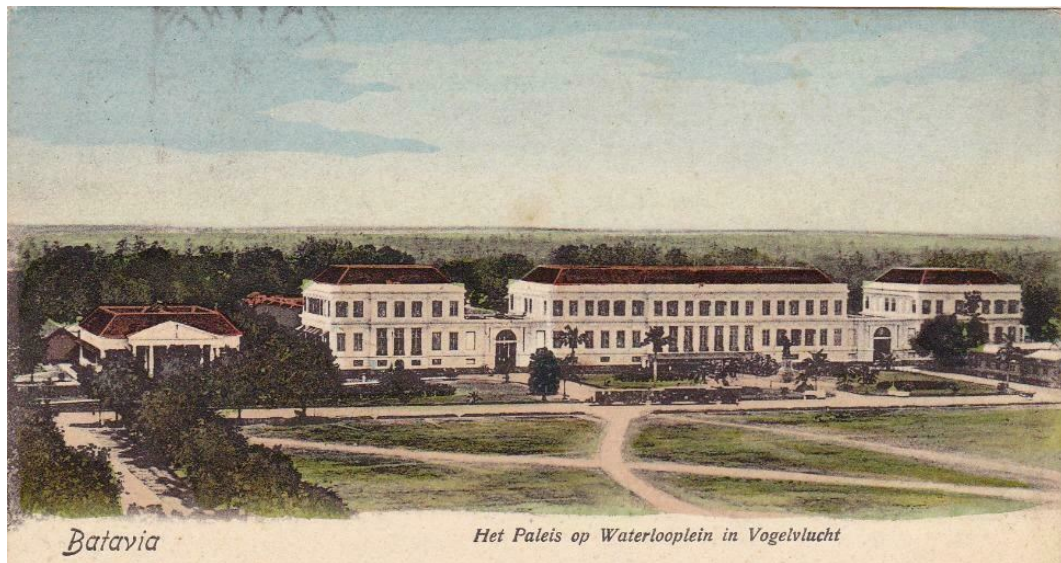
Fig. 2. Daendel's Palace or the White House, Circa 1900
Source: Author(s) (2022)

As told by Passchier (2016) Lieutenant Colonel Schultze has been credited with preparing the plan for the new governor's palace, accompanied by J.Jongkind as landscape architect. Schultze employed Empire Style (see Fig. 2 and Fig. 3) to represent the prevailing architectural styles of the era (1804-1815). The construction began--with the involvement of Chinese contractors--as soon as the plan was approved: one main building in the middle and two identical wings on each side (Fig. 4). Furthermore van Reenen (2005) said that the contractor Tjung See employed 438 bricklayers and carpenters in June 1809, but by November the number reduced to 126 carpenters. The main functions are located on the second and third floor, while services and other supporting facilities are on the first

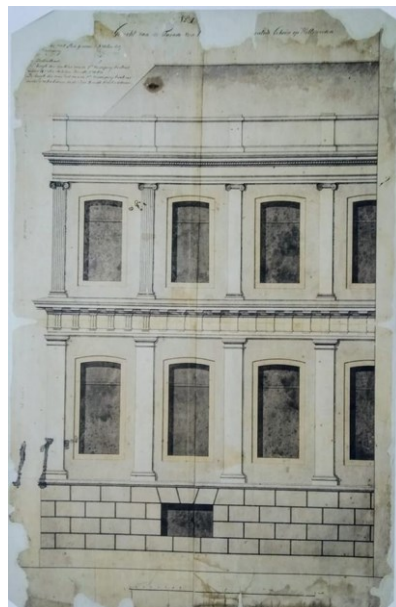
Fig. 3. Facade From the Original Drawing, Circa 1809
Source: ANRI (2002)

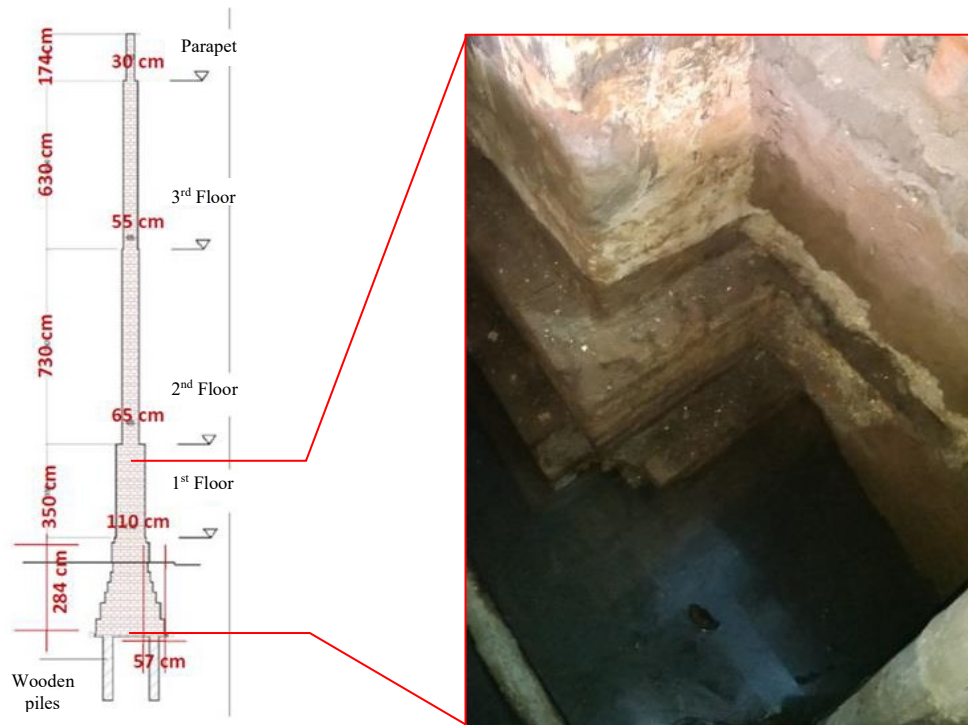
The load bearing masonry building was supported by a wooden pile and brick foundation (Fig. 7). The lowest part of the bearing wall has a thickness approximately 110 cm, gradually decreasing to 65 cm at the second floor, and 55 cm at the third floor (Fig. 7). The floor was built by a series of wooden beams and planks in the old manners as usually found in old buildings from that period—except that the first floor, which is on the ground level, is mainly covered by natural stones.

Fig. 7. Masonry Wall Section (Left) and Brick Foundation, Construction Technology of the Past (Right)
Source: Kementerian Keuangan (2020) (Left) and Author(s) (2020) (Right)

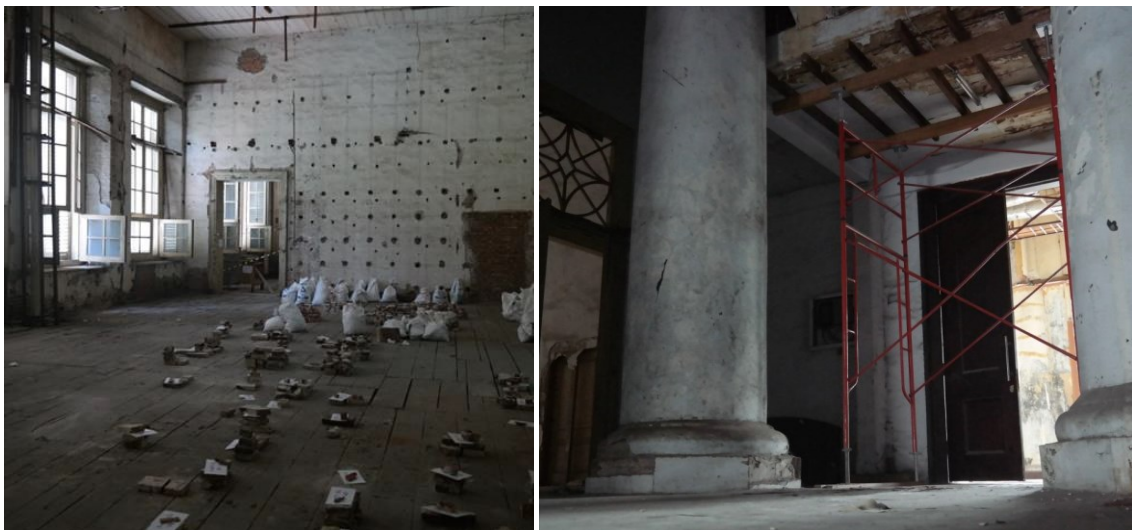
As required, samples of bricks had to be tested for its shear strength (see Fig.8). The result was quite remarkable: most of the bricks tested were in a good shape, but when bricks act as a wall it had to be strengthened to some extent. Then, selected walls would be reinforced by carbon fiber reinforced polymer applied on both sides symmetrically—as suggested by the structural engineer (see Fig.8) to fulfill the seismic safety's requirement (see Fig. 9). On the other hand, broken or badly damaged wooden beams and planks are difficult to replace. What is available in the market is smaller in size and lower in quality. To solve the problems, a steel beam was used with regrets.

Fig. 8. Sample of Bricks Prepared for the Shear Strength Test. Wooden planks in bare condition need some repair and maintenance (Left) and Interior of north wing building: the second floor. Some wooden materials need repair, maintenance or replacement (Right).
