# Action on Heritage Conservation of Wooden Structures

## Enhancing the Cultural Spaces of Pontianak by Reconstruction of a Traditional Malay House

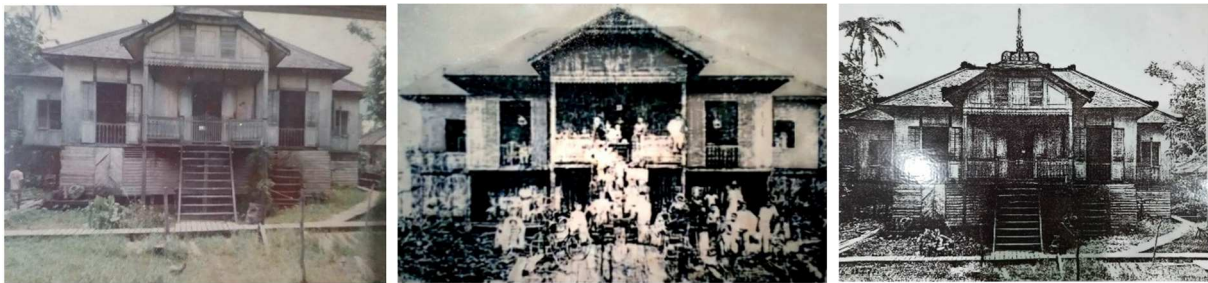
**Fig. 1.** The front façade of Hajjah Salmah house in the early 1930s. This picture was collected from the private collection of M Hatta bin H Saleh bin H.M. Arief.

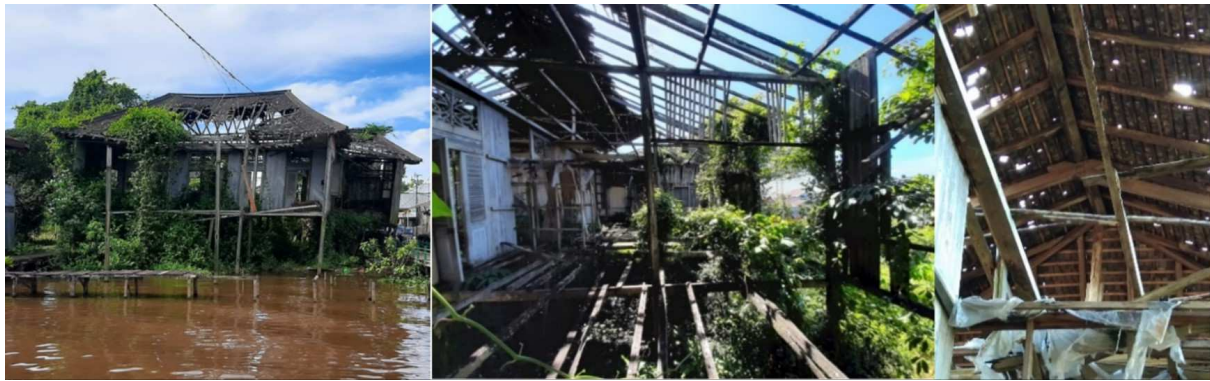
This house is estimated to be last inhabited by the heirs until the 1985s. Afterward, Hajjah Salmah's house is no longer inhabited for reasons of the structural material condition and safety of the occupants because the construction conditions of the house are increasingly worrying about living in. At the end of 2019, Hajjah Salmah's house was found with the condition of the failure of some roofing material, some of the leaned foundations, partly missing components of the walls, an un-covered floor,

weathered beams and rumbles, and some missing or damaged opening parts.

**Fig. 2.** Some pictures were taken in early 2019 about the house condition before reconstruction. The condition of structures was found to shift because of riverbank erosion and material decay.

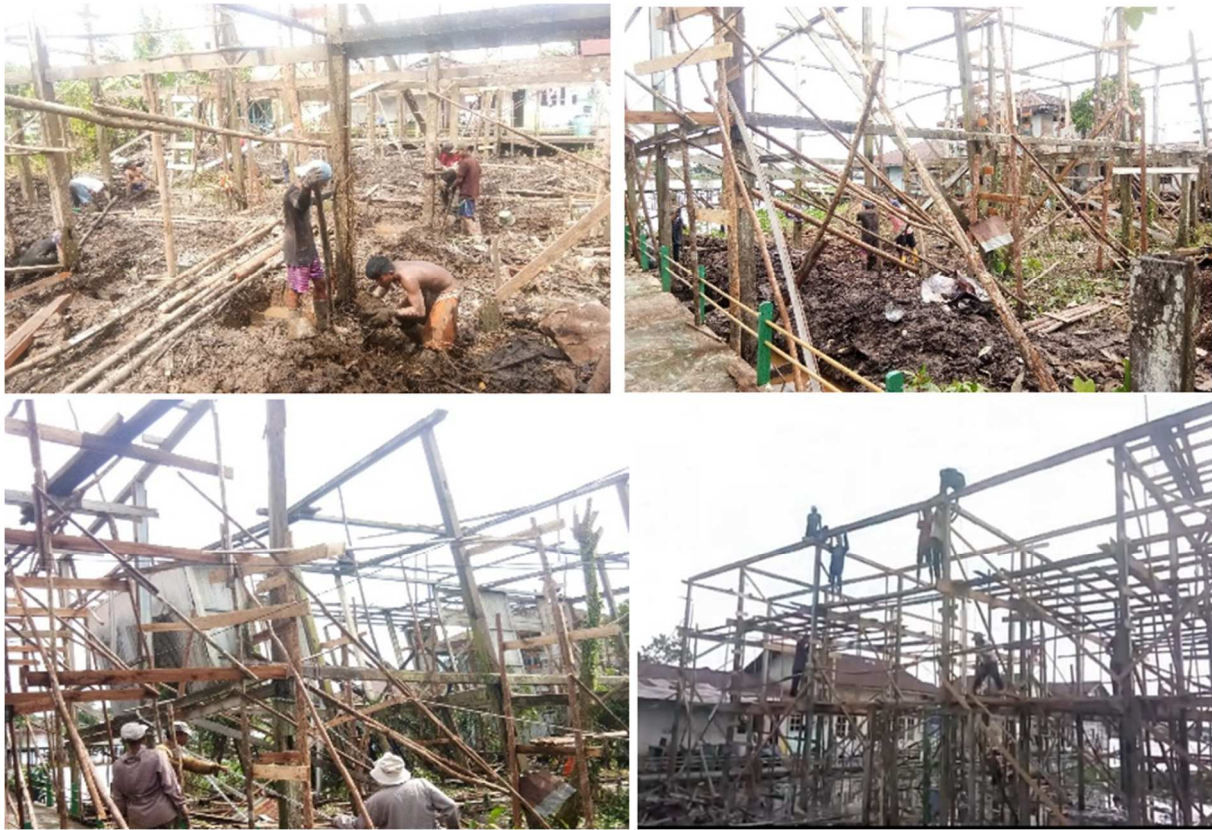
**Fig. 5.** Construction process on the reconstruction of Hajjah Salmah House. Re adjustment of house structure

For this reason, adjustments are made to the house structure of the main house by adjusting the position so that it is back upright. In addition, reinforcement is carried out on the foundation for structural elements that have undergone weathering or subsidence. According to Zain (2016), the Limas-type house generally uses a continuous wooden base under the poles with the placement in line with the direction of the river stream. The condition of the wooden bases under the poles was found to fit the statement of Zain (2016) regarding the readjusting of the main structural foundation of the main house. The old wooden basis was found in continuous elements with the placement in line with the direction of the river stream. According to existing conditions, the continuous wooden basis was maintained in its original condition. Some Parts of the supporting foundation in structural elements will be reinforced with additional supporting foundations on both sides. According to Zain & Putro (2021), there were pieces of porous wood around foundation piles in severe condition. Wood on the inside structures of the house was decayed by insect attacks. To the condition of some porous wooden piles, substituting a new material becomes a decision to upgrade the house's structural strength. In West Kalimantan, where many traditional houses are located, Zain (2012) claims that continuous bearing pads enhance a traditional house structure by minimizing the shift on wooden frames that is not synchronous in one of the grids caused by a weakness in the soil's carrying capacity.

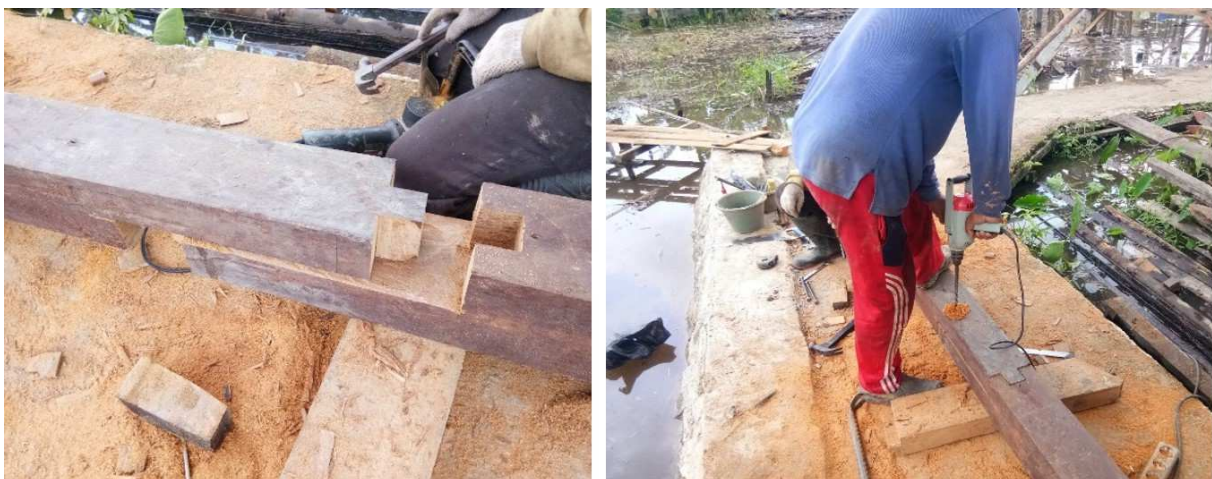
**Fig. 6.** The use of traditional wooden joint for new substitution element on the Hajjah Salmah house

According to Zain (2012), the wooden connections between beams and columns on the wall structure of Malay traditional houses used wooden nails (*Pasak*) to strengthen the joints. Zain (2016) stated that traditional Malay houses generally use hardwood for the main structure and the type with the lower class for the supporting structure. Based on this statement, the substitution of the main structure is directed to the reuse of the original material that can be maintained during the reconstruction. It is also important to determine that the traditional wood connection method must be used to replace the damaged structural elements.

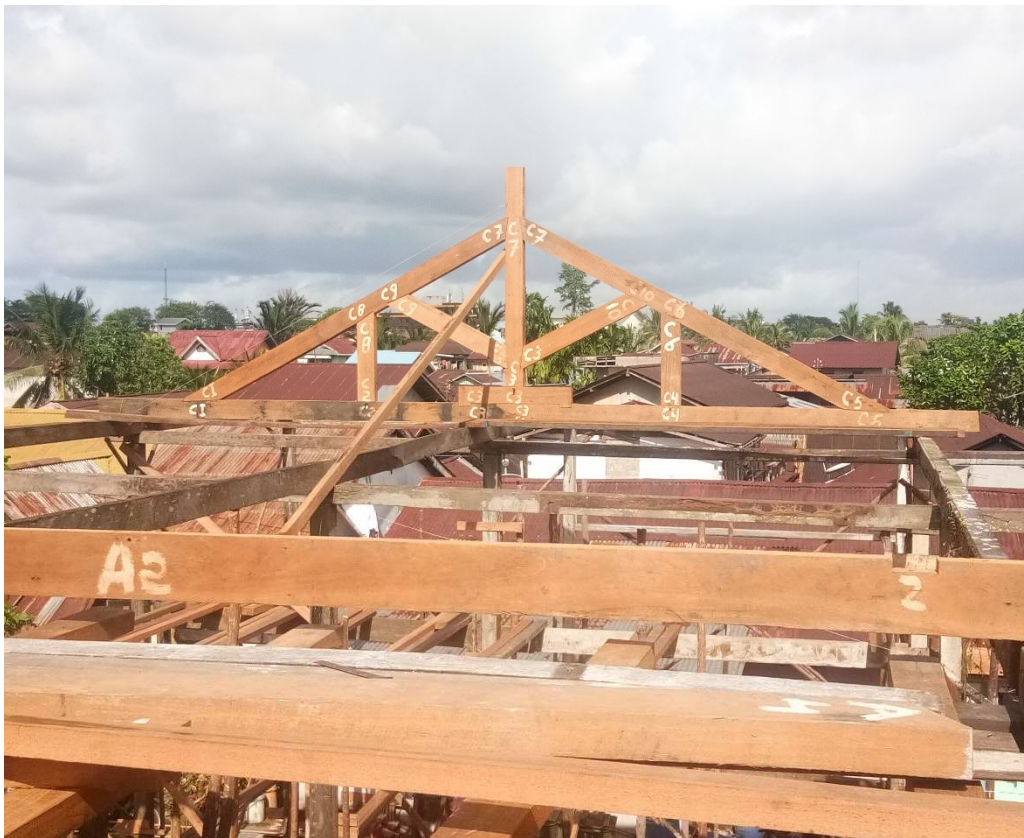
**Fig. 7.** Trestle structure for roof construction of the Hajjah Salmah house

The architecture of the traditional Malay houses in West Kalimantan, Indonesia, one national heritage, has contributed to particular characteristic structures. The joint wood connection technique with holes and pins was used to construct wooden house structures in West Kalimantan. According to Zain (2012), the connection technique at the frame joint must spend full attention to some installation of the supplementary construction to make stable structural elements have been installed as a whole. The supplementary construction will be released one by one after the wooden boards, as wall structures are established on all sides of the house. The upper structure consists of a frame and roof surface. In some traditional houses in West Kalimantan, simple structures were used for the roof structure. According to Gabriela et al. (2017), the house's traditional structure on the roof comprises the top plate, prop, ridge, roof ridge, roof valley, rafter, and roof sheathing. There are found only two main barks in the roof structure: the post (vertical) and the beam (horizontal). To strengthen the roof structure, the trestle construction chosen for the current structure is more appropriate than the traditional structure with post and beam by the rationale to have a stable construction for the house.

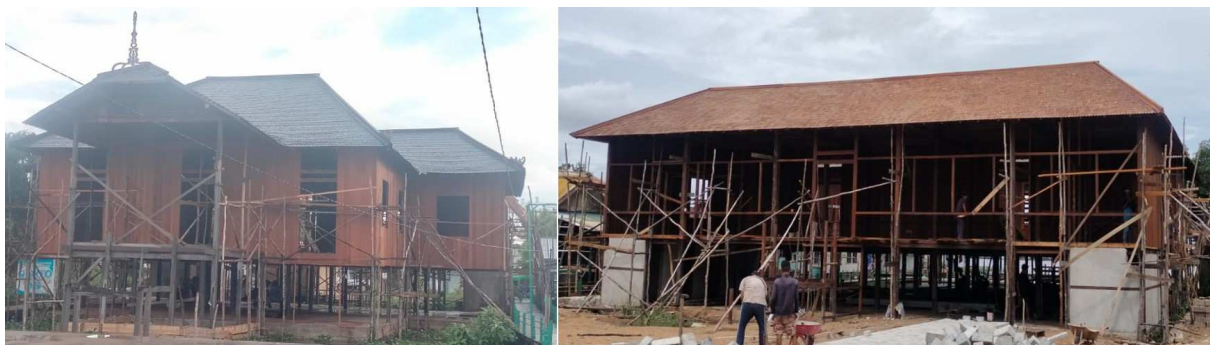
**Fig. 8.** Current progress on the reconstruction of Hajjah Salmah house
